Weld Heat Tented Area Induced Failure of Boiler Water Wall Tubes in Power Generation Plant

A. El-Batahgy* and Y. Hewedy**

Abstract: The subject boiler is a vertical type with a capacity of 2063 ton/hr steam. Its operating and design pressure are 2608psi (18MPa) and 2928psi (20.2MPa) respectively while maximum outlet operating temperature is 1008°F (542.2°C). Water wall tubes are seamless tubes made of SA 210 and SA 213 T2 steels with nominal outer diameter of 2.5-3.0" (63.5-76.2mm) and wall thickness of 0.25-0.313" (6.35-7.95mm). After 77360 operating hours, some water wall tubes have experienced leakage. Leaked tubes were subjected to different non-destructive and destructive examinations to clarify cause of failure.

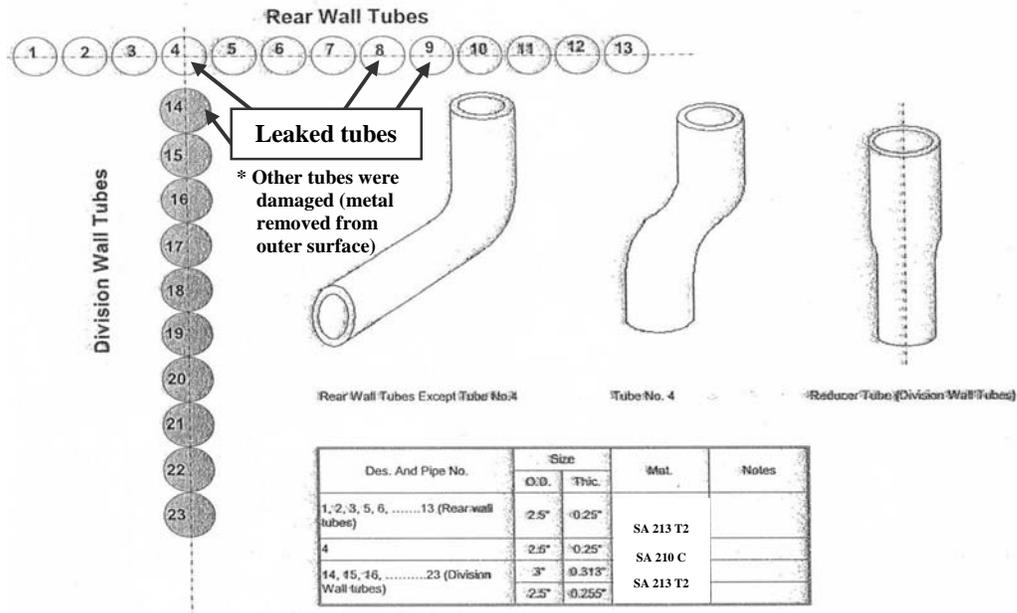
After 77360 operating hours, some water wall tubes have experienced leakage just below the firing zone of the boiler. Visual inspection indicated that leakage took place in base metal, not in circumferential welds of tubes. Twenty two tubes samples with 1000mm length from leaked region that included 13 rear water wall tubes and 9 division water wall tubes were cut, removed and subjected to detailed investigation for failure analysis. Figure 1 shows schematic illustration of location and configuration of failed water wall tubes.

Fig. 1 Schematic illustration of location and configuration of failed rear and division water wall tubes of the boiler.

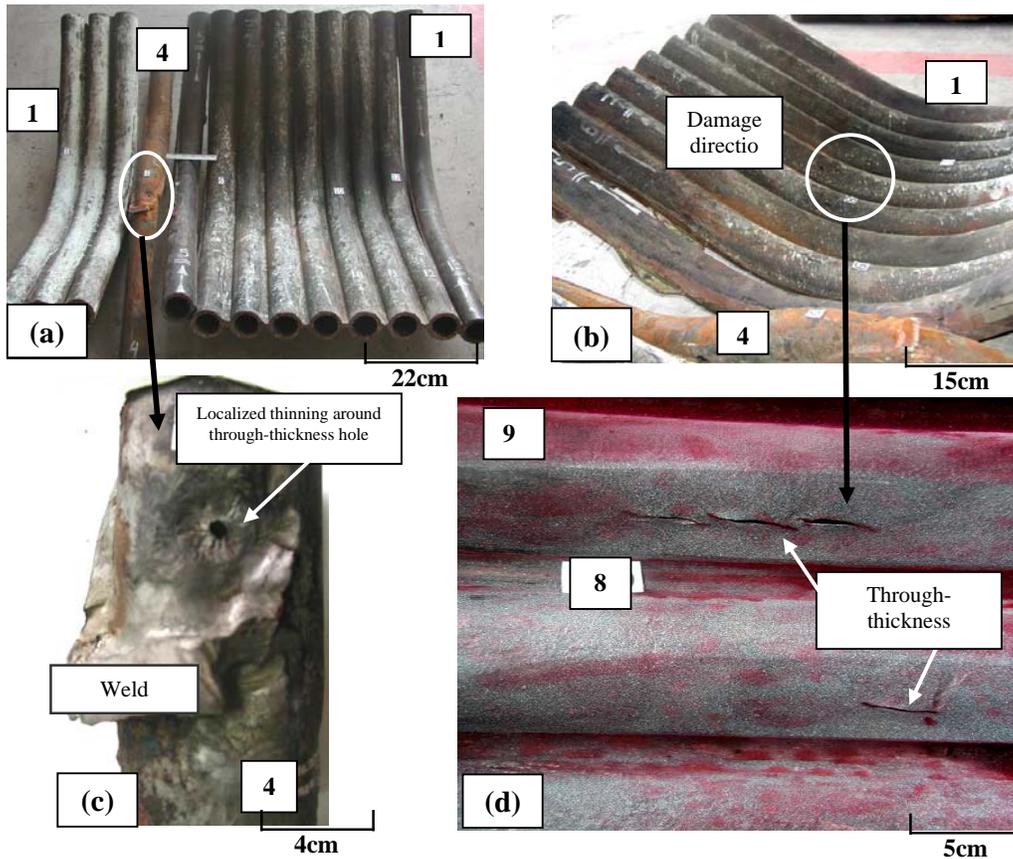
The failed water wall tubes samples were carefully examined before sectioning it for destructive investigations. General and close up views from different sides of failed rear water wall tubes are shown in Fig. 2. One important notice is the through-thickness hole of tube 4 (Fig. 2-c) and the through-thickness rupture of tubes 8 and 9 (Fig. 2-d). Another notice is the external damage of other tubes where metal was removed from outer surface. It seems that external damage or reduction in tube wall thickness from outer surface was occurred by mechanical action after leakage took place. It is observed that through-thickness hole where leakage occurred in case of tube 4 is confined to localized thinned zone close to weld region. Generally, tube failure is outward (failure direction is from inside toward outside) and characterized by a thin edge. No bulges were observed at either failed or non-failed tubes. Both dye penetrant and magnetic particles examinations of rear water wall tubes revealed no surface cracks around either failed or non-failed zones.

Fig. 2 General (a, b) and close up (c, d) views of failed rear water wall tubes showing through thickness hole close to weld region of tube 4 and through-thickness rupture at externally damaged (thinned) zone of tubes 8 and 9.

Visual investigation indicated localized thinning with through-thickness holes of tubes 4 and 14. It showed external damage of other tubes where metal was removed only from outer surface. It is noticed that localized thinning was occurred as a result of metal removed from only outer surface. It is observed also that leakage or through-thickness hole was confined only to localized thinned zone. Visual investigation showed no damage on inner surface of either leaked or non-leaked tubes. In other words, except through-thickness hole or rupture, no internal damage was occurred. However, visual investigation indicated that through thickness hole, where leakage was occurred in case of tubes 4 and 14 is close to weld region. .

It was recommended that boiler tubes to be checked using different non-destructive methods including visual investigation and thickness measurements during the nearest shut down and all thinned zones to be replaced.

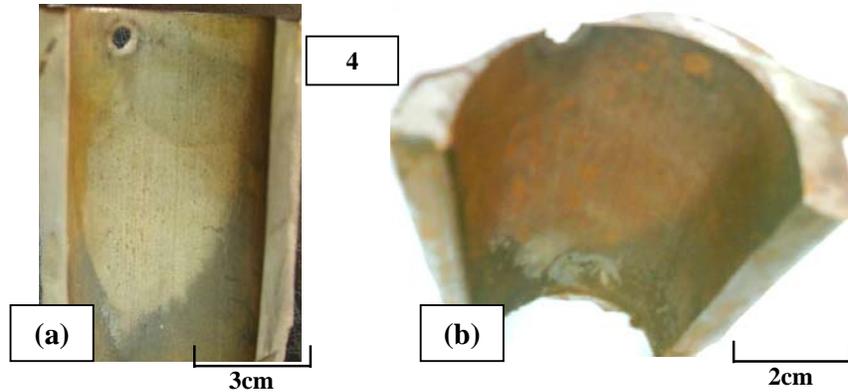
Failed rear water wall tubes were split longitudinally around its leaked zone where its inner surface was carefully investigated. Enlarged views of inner surface and cross section of leaked zone of tube 4 are shown in Fig. 3. It is obvious that no internal damage was occurred around leaked zone. Localized thinning is confined to outer surface of leaked zone. Enlarged views of cross sections of leaked tubes 8 and 9 are shown in Fig. 4. One important notice is the localized thinning as a result of metal removed from outer surface. It can be noticed also that leakage or rupture is confined to localized thinned zone. Except through-thickness rupture, no internal damage was occurred. Localized thinning of tubes around leaked zones has been confirmed by thickness measurements using UT-thickness meter. Results of thickness measurements indicated that wall thickness was reduced from 6.5mm to about 3.1mm around leaked zones.

Fig. 3 Photographs of inner surface (a) and cross section (b) of leaked zone of tube 4 showing no internal damage around leaked zone. Localized thinning is confined to outer surface of leaked zone.

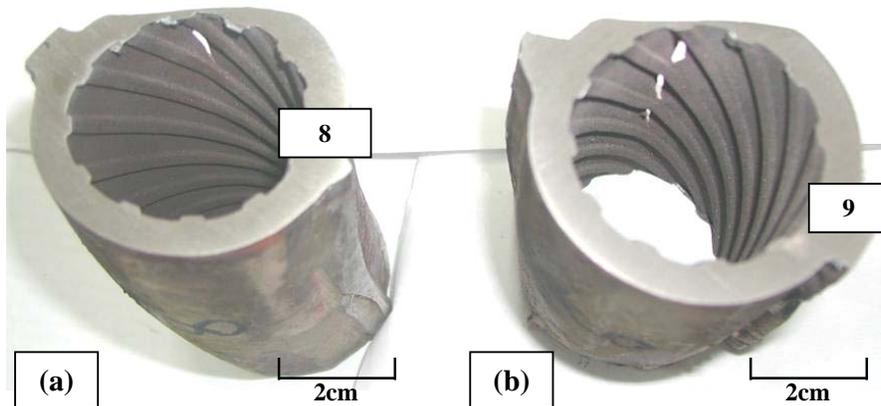
Fig. 4 Cross sections of ruptured zone of rear water wall tubes 8 and 9. Except through-thickness rupture at localized thinned zone, no internal damage occurred. Localized thinning is related to metal removed from outer surface.

On the other hand, it is believed that localized thinning of other tubes including tubes 8 and 9 is related to mechanical damage (not thermal damage) after leakage of tubes 4 and 14 took place. In other words, water jet produced after failure of tubes 4 and 14 took place has resulted in metal removal (by mechanical action) from outer surface of surrounding tubes that in turn resulted in severe thinning and subsequently overheating that means microstructure degradation.

Severe thinning of tubes 8 and 9 together with microstructure degradation will result in increase in boiler pressure above the maximum safe working pressure that in turn will result in initiation of intergranular or grain boundary cracking leading finally to outward rupture.

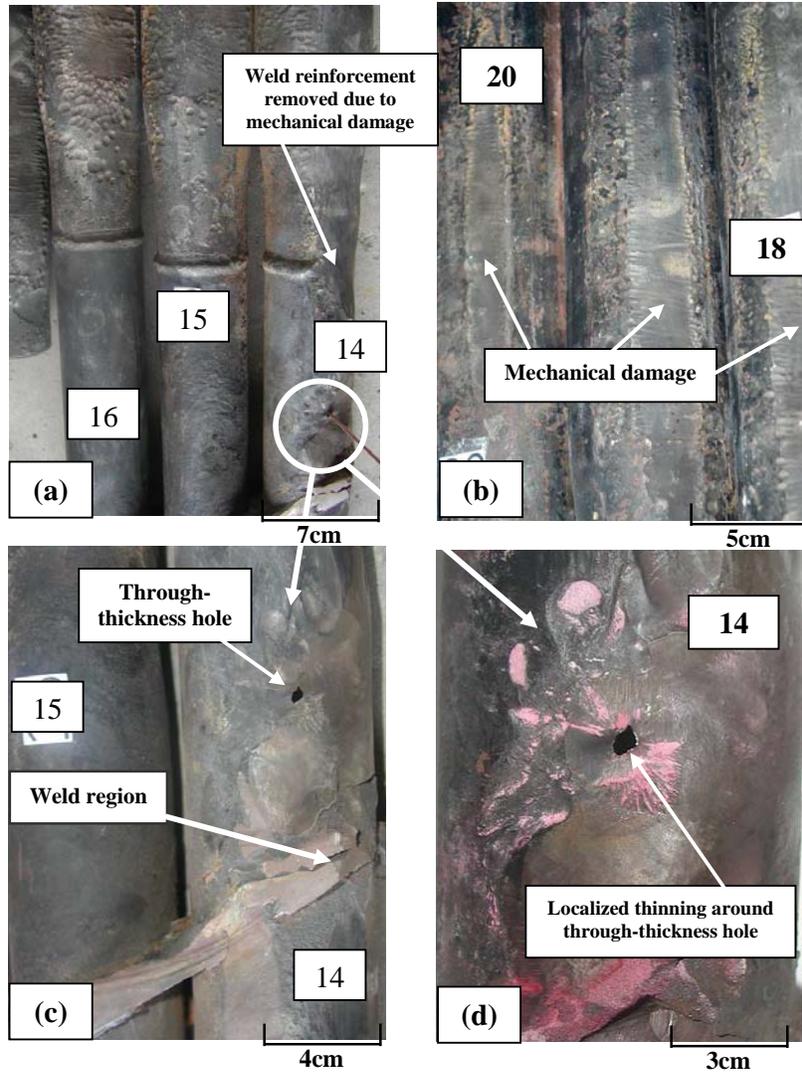
General and close up views of failed division water wall tubes are shown in Fig. 5. The most important notice is the through-thickness hole of tube 14. Note external damage of other tubes where metal was removed from outer surface. It seems that such external damage or reduction in wall thickness is related to metal removed from outer surface by mechanical action after leakage took place. It should be reported also that localized thinning where leakage was occurred in case of tube 14 is close to weld region. Dye penetrant and magnetic particles inspections of failed division water wall tubes showed no surface cracks around either leaked or non-leaked zones.

Fig. 5 Photographs of failed division water wall tubes showing through-thickness hole close to weld region of tube 14. Note mechanical damage of other tubes where metal was removed from outer surface. Dye penetrant investigation disclosed no surface cracking.

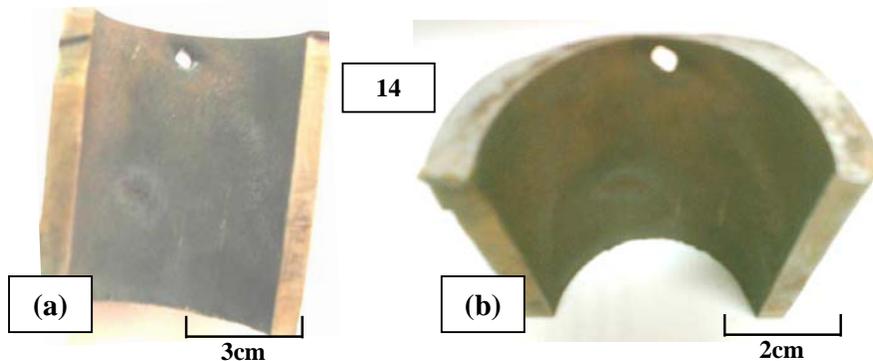
Failed division water wall tubes were split longitudinally where its inner surface was carefully investigated. Enlarged views of inner surface and cross section of leaked zone of tube 14 are shown in Fig. 6. No internal damage was observed around leaked zone. Localized thinning is confined to outer surface of leaked zone. In other words, localized thinning was occurred as a result of metal removed from outer surface. Except through-thickness hole where leakage occurred, no internal damage was observed. Localized thinning of tubes around leaked zones has been confirmed by thickness measurements using UT-thickness meter. Results indicated that wall thickness was reduced from 7.2mm to about 3.3mm around leaked zone.

Fig. 6 Photographs of inner surface (a) and cross section (b) of leaked zone of division water wall tube 14 showing no internal damage around leaked zone. Note localized thinning on outer surface of leaked zone.

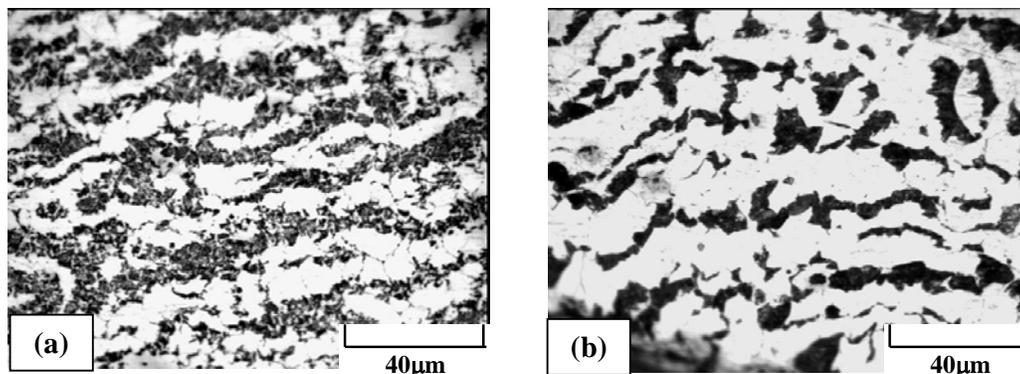
Regarding metallographic examinations, high magnification optical microscopic photographs of cross sections taken from leaked and non-leaked zones of rear water wall tube 4 are shown in Fig. 7. Microstructure of leaked zone exhibited remarkable degradation where complete decomposition of pearlite into ferrite and spheroidal carbides is observed (Fig. 7-a). On the other hand, no considerable degradation in microstructure was occurred at non-leaked zone where almost normal ferritic-pearlitic structure is still existed (Fig. 7-b).

Fig. 7 Optical micrographs of cross sections taken from leaked (a) and non-leaked (b) zones of tube 4. Note complete decomposition of pearlite into ferrite and spheroidal carbides at only leaked zone.

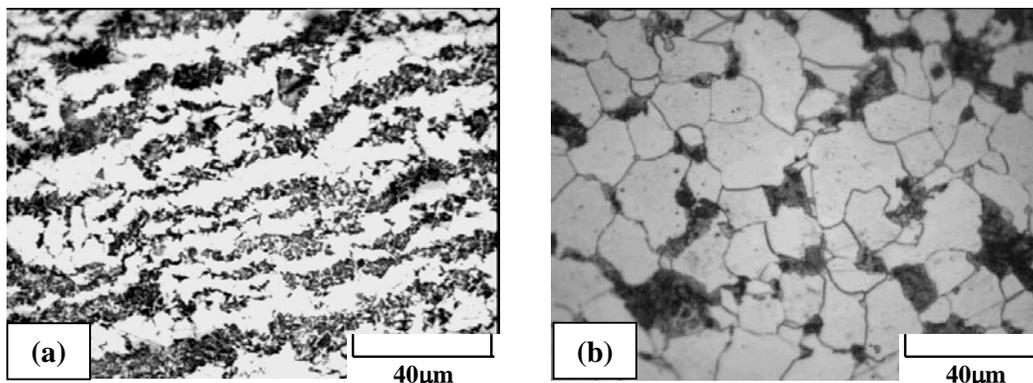
Optical micrographs of cross sections taken from leaked and non-leaked zones of division water wall tube 14 are shown in Fig. 8. The important notice is the complete decomposition of pearlite into ferrite and spheroidal carbides at leaked zone (Fig. 8-a) while almost normal ferritic-pearlitic structure is observed at non-leaked zone (Fig. 8-b).

Fig. 8 Optical micrographs of cross sections taken from leaked (a) and non-leaked (b) zones of tube 14. Note complete decomposition of pearlite into ferrite and spheroidal carbides at only leaked zone.

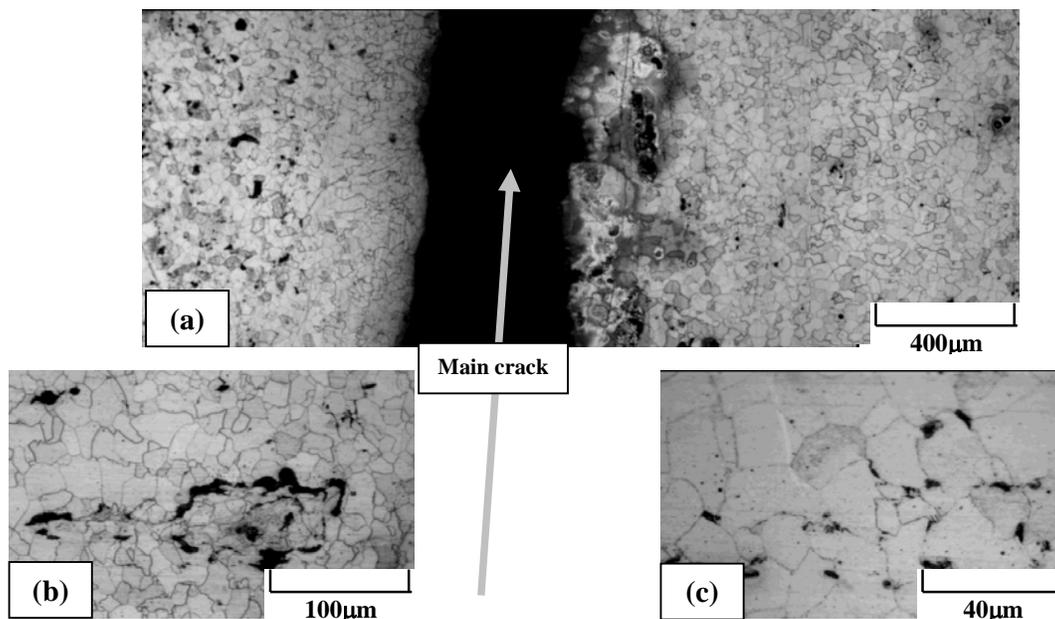
Optical micrographs with different magnifications of a cross section taken from ruptured or leaked zone of rear water wall tube 8 are shown in Fig. 9. One important notice is the occurrence of decarburization around main crack (Fig. 9-a). Higher magnification of decarburized zone disclosed formation of creep voids that means remarkable degradation of microstructure Fig. 9-b, c). It should be reported that optical microscopic investigation of cross sections taken from damaged or thinned but non-leaked zones showed deformed ferritic-pearlitic structure with partial decomposition of pearlite into ferrite and spheroidal carbides.

Fig. 9 Optical micrographs of ruptured zone of tube 8 showing decarburization and creep voids around main crack.

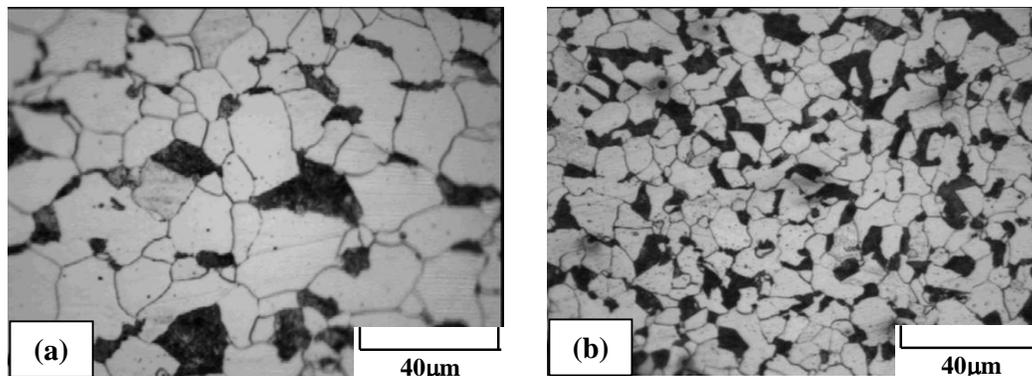
Optical micrographs of cross sections taken from thinned and non-thinned zones of non-leaked tube 10 are shown in Fig. 10. It can be noticed that coarser ferritic pearlitic structure was observed at thinned zone (Fig. 10-a) in comparison with non-thinned zone (Fig. 10-b).

Fig. 10 Optical micrographs of cross sections taken from thinned (a) and non-thinned (b) zones of non-leaked tube 10 showing coarser ferritic pearlitic structure at thinned zone.

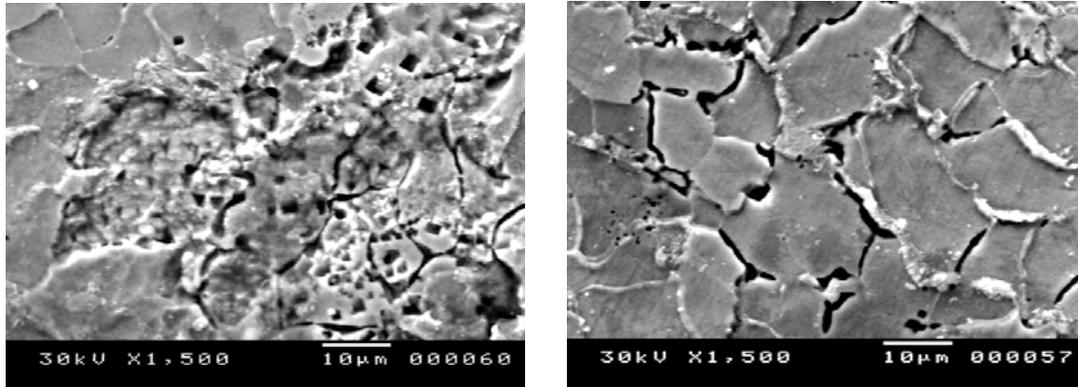
In order to help in identification of failure mechanism, cross sections of leaked zones were examined using scanning electron microscope. Scanning electron micrographs of a cross section taken from leaked zone of rear water wall tube 4 are shown in Fig. 11 while those of a cross section taken from leaked zone of division water wall tube 14 are shown in Fig. 12. Scanning electron microscopic investigation confirmed complete decomposition of pearlite into ferrite and spheroidal carbides, formation of creep voids and grain boundary micro-cracking.

Fig. 11 Scanning electron micrographs of a cross section taken from leaked zone of rear water wall tube 4 confirming complete decomposition of pearlite into ferrite and spheroidal carbides, creep voids, and grain boundary micro-cracking.

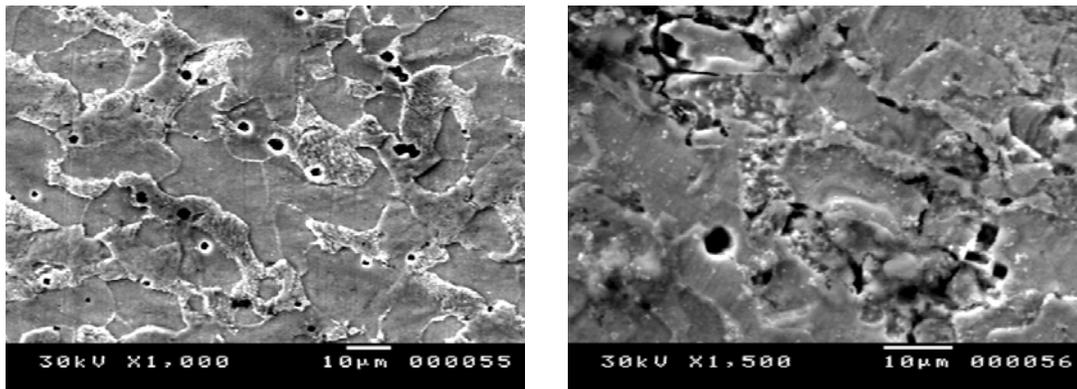
Fig. 12 Scanning electron micrographs of a cross section taken from leaked zone of division water wall tube 14 confirming complete decomposition of pearlite into ferrite and spheroidal carbides, creep voids, and grain boundary micro-cracking.
