Experimental verification of the parameters affecting the characteristics of mechanical and corrosion behaviour of conventional and high-speed remote scanner laser welding of stainless-steel joints

To cite this article: Ahmed. M. El-Aziz *et al* 2019 *IOP Conf. Ser.: Mater. Sci. Eng.* **610** 012008

Ahmed .M. El-Aziz¹, Mahmoud Abou El Khier^{1,3}, Horest Exner²

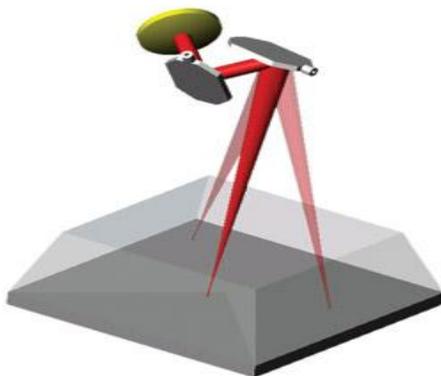
Figure 1 Working area of laser scanner system
(Courtesy of trumpf laser technique) [11]

High speed remote scanner laser fig.1 welding on large thicknesses is a generally new topic; so it is essential that high penetration is made inside these thick-nesses with least distortion to acquire optimum results [4]. Laser beam welding gives Weldment least distortion and minimum heat-affected zones compared to conventional tungsten inert gas (TIG) welding which offers a solution for welding critical joints, and for situations where small or exceptionally precise welds are required it produces a high-quality and high-purity weld compared with other joining processes, which is crucial in many applications. Keyhole welding or deep penetration welding is a procedure in which the laser beam penetrates partially or completely through a specimen forming a keyhole; so as the laser beam progresses fig.2, molten metal fills in behind the hole to form the weld bead; which results in a homogenous weld. At the point when high laser beam power densities are accomplished, deep- penetration fusion welding is cultivated by a keyhole energy transfer mechanism. The price of TIG welding services is also usually quite affordable; but the process has a low deposition rate and if performed improperly, inclusions, contaminations, and unbalanced heating can cause products to become warped or defective [5][6]. In the auto-motive industry the laser technology was implemented to increase the productivity, strength of constructions and new designs [7,8]. First applications with long welds on the vehicle body are currently trailed by replacement of resistive spot welds by short laser welded fastens with the benefit of shorter preparing times.

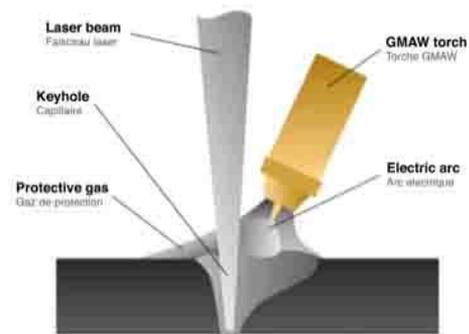
Figure 2 Key hole penetration between
Laser and TIG

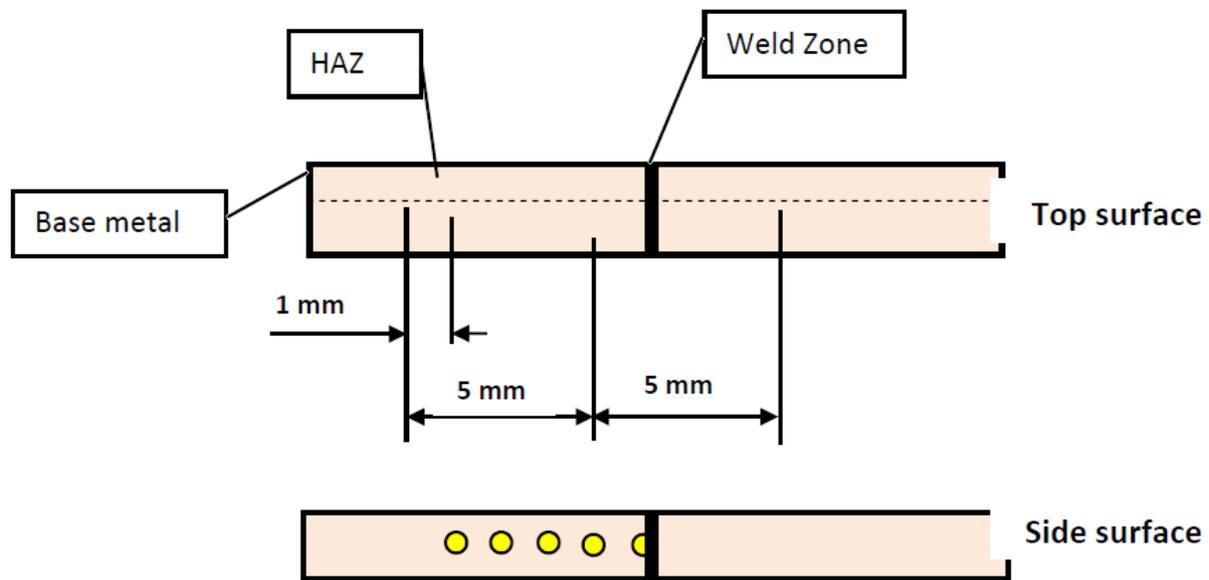
Figure 3 Schematic for specimen shown Base metal-HAZ-Weld zone

The Vickers micro hardness was used to attain the hardness of the specimens across line path according to (ASTM E384-99), [14] standard done through the top and side surfaces of the specimen of the laser-welded specimens and the Tig welded specimens as shown in fig.3 The load applied was 300 g and the loading time was 15 s by equipment Buehler Micromet 5100 series. All the specimens were ground to provide a smooth surface for the test.

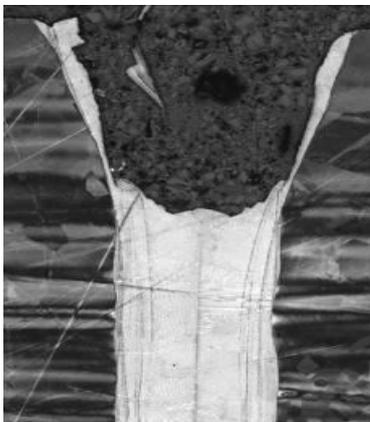
Figure 4. 1.4301 Laser weld under fill

It is observed that there is different types of defects where detected happen from welding as shown in fig.4 and fig.5 for laser welded and Tig welded specimens respectively. The most common defect observed is complete penetration and under fill of the weld bead due to the reflection of the incoming laser off the surface of the stainless steel same for the Tig happened due to the filler rod melting. A solution to decrease the defects so decreasing the reflectivity of the laser off the surface of the material. It can be coating of the surface to absorb and decrease the surface reflection. [21]

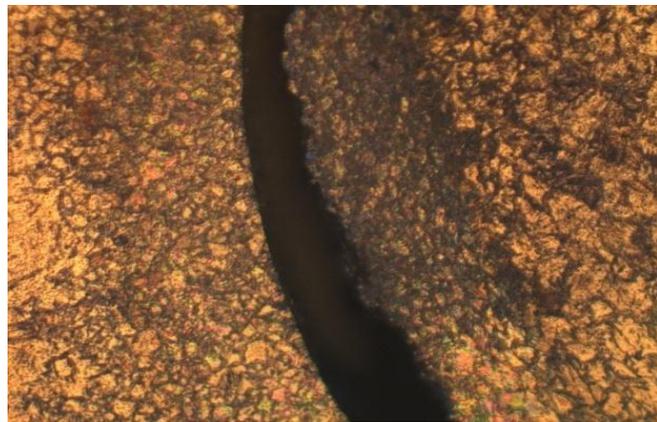
Figure 5. 1.4301 8mm Tig weld under fill

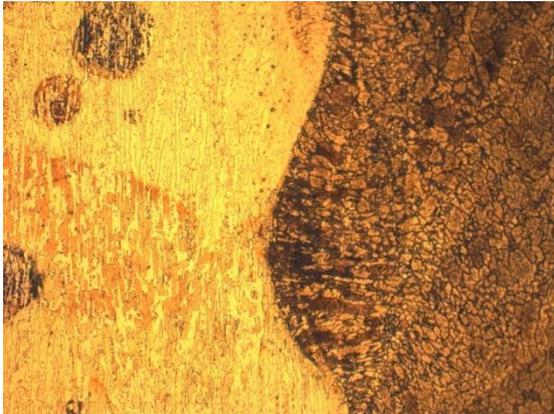
Figure 6. 1,4301 TIG weld

Observed from optical microscope that the grain size in the base metal and HAZ its much bigger before deformation than the weld zone that gives smaller grain size and hardened the stainless steel. Elongation through grains is shown in the different zones in the weld towards the HAZ. The carbide precipitates seen clearly due to the high temperature of welding which caused the sensitized stainless steel [22,23]. As shown in fig.6,7 for Tig weld compared to the laser weld fig.8,9.

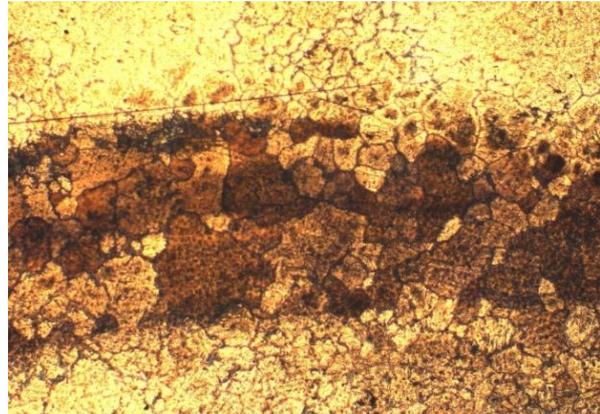
Figure 7. 1,4301 TIG weld

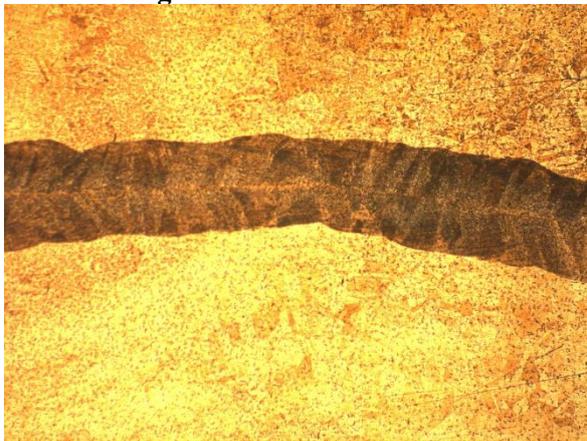
Figure 8. 1,4301 Laser weld

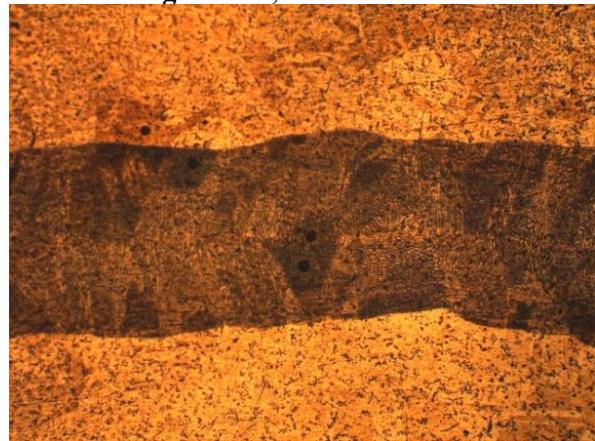
Figure 9. 1,4301 TIG weld

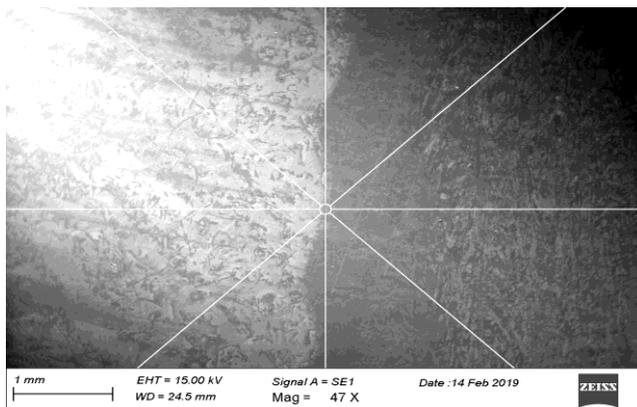
Figure 10. 1,4301 A.S.S SEM weld zone TIG weld

SEM is done to observe further information about grains behavior in the weld zone figs 10-12

After Scanning electron microscope observed more investigation about the grains behaviour inside the weld zone and HAZ. there is a difference. The grain size of this material was very clear in figure 10,12 by the help of magnification we can see its very small and may be this explains why the hardness at this region is higher. doubting that these black spots are carbides figure 11 but after making the EDX table 3 and comparing between the HAZ and base metal or even though change in percentage of the iron or chromium so this means that there is no precipitation and the heat generated from the remote scanner welding just make recrystallization of the grains. also the heat affected zone has a lot of grain orientations which will the properties of the material according to the direction of the grains.

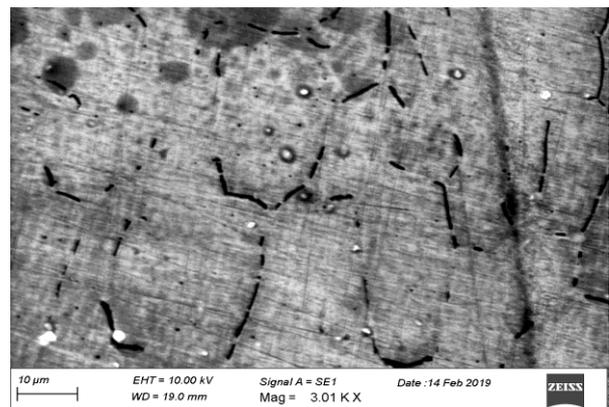
Figure 11. 1,4301 A.S.S SEM HAZ at TIG weld line

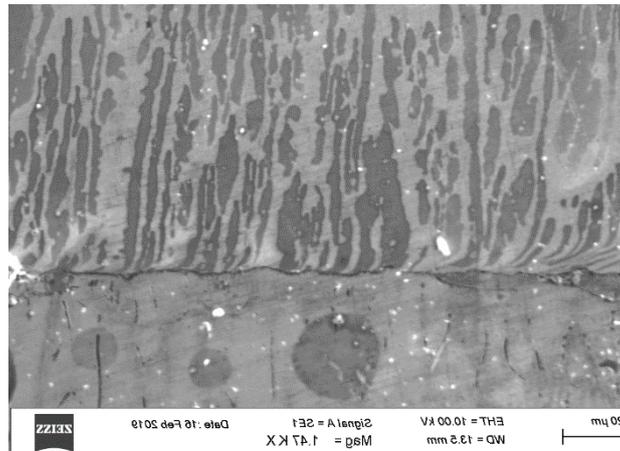
Figure 12. 1,4301 A.S.S SEM Weld zone at LASER weld

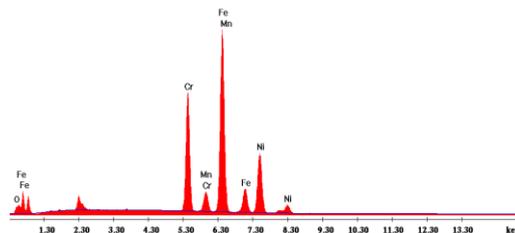
Figure 13- EDX 1.4301 A.S.S at HAZ Laser weld

Table 3. As explained in fig.13, of Energy-dispersive x-ray (EDX) that :

Element	Wt%	At%	K-ratio	Z	A	F
O k	2.02	6.71	0.0082	1.1371	0.3534	1.0036
Cr k	21.24	21.65	0.2379	0.9882	0.9807	1.1557
Mn k	1.25	1.21	0.0125	0.9721	0.9920	1.0352
Fe k	50.23	47.66	0.4880	0.9925	0.9373	1.0441
Ni k	25.25	22.78	0.2191	1.0127	0.8572	1.0000
Total	100.00	100.00

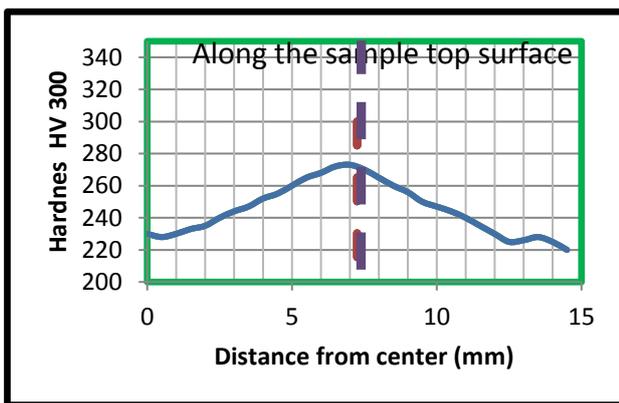
Figure 14- 1.4301 A.S.S top surface Laser weld hardness chart

After performing hardness testing on the work pieces, it is a general pattern that the hardness increments towards the weld line until it is at its maximum at the centre at the weld zone going from the base metal to HAZ then to weld-zone, as found in figures (14 and 17) for top surfaces, figure (14 and 15) for side surfaces. The phenomenon might be clarified by a purpose behind stainless steel 1.4301. The main reason may be because of the grain refinement and the formation of smaller grains as in the small grain, no dislocation can travel more than 1 Unit of distance. This type of strengthening is known as Hall-Patch strengthening. which implies more grain boundaries. These grain boundaries give more strength to the material which causes an increase of the hardness. For Austenitic stainless steel 1.4301 (304) the hardness for the welded specimens were much higher than the unwelded. There is a great increase in the TIG weld over the laser weld compared to the unwelded.

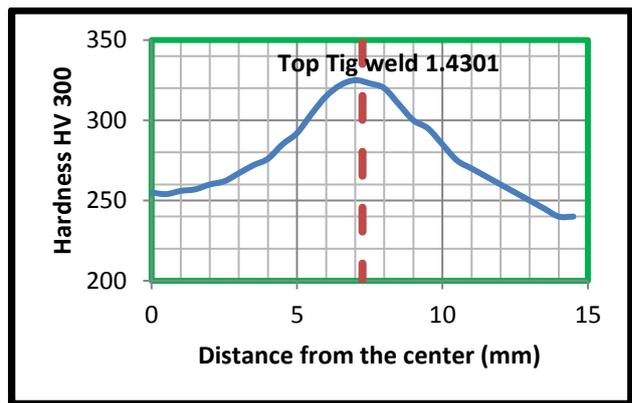
Figure 15-1.4301 Top surface A.S.S TIG weld hardness chart

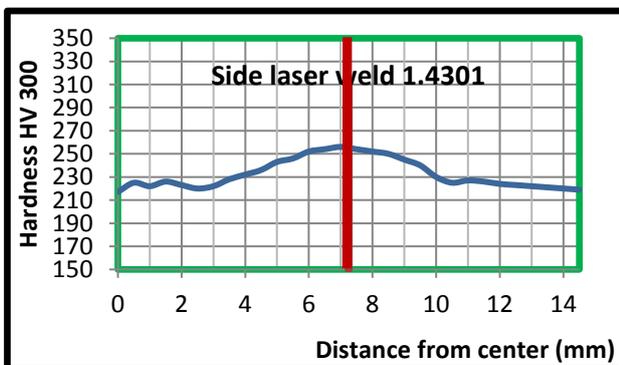
Figure 16 1.4301 A.S.S side surface laser weld hardness chart

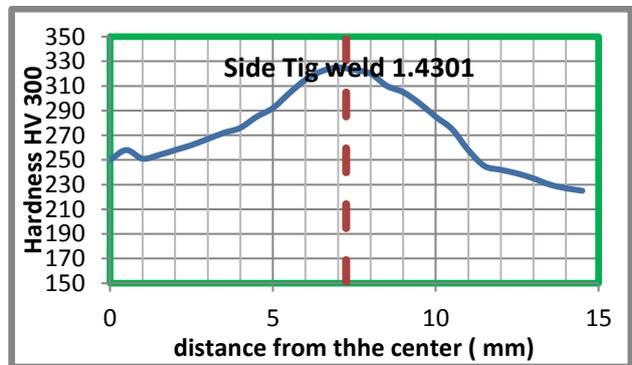
Figure 17 1.4301 A.S.S Side surface TIG weld hardness chart

Since, a very large increase in the ferrite is observed, where the primary phase becomes the ferrite phase, so a very large increase in the hardness is observed reaching as much as 54% more than the original hardness as seen in Figure 17. comparing to literature result for the unwelded sample which is 200 HV close to the result in figure 18. Which is 197 HV compared to the welded samples higher than the unwelded.

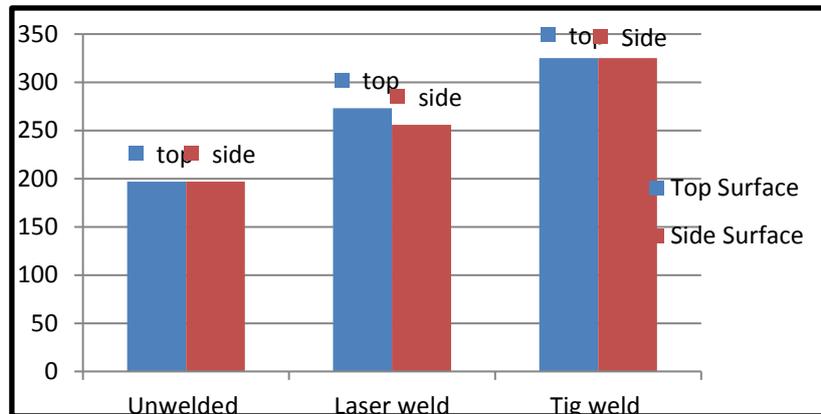
Figure 18-Histogram illustration for stainless steel 1.4301

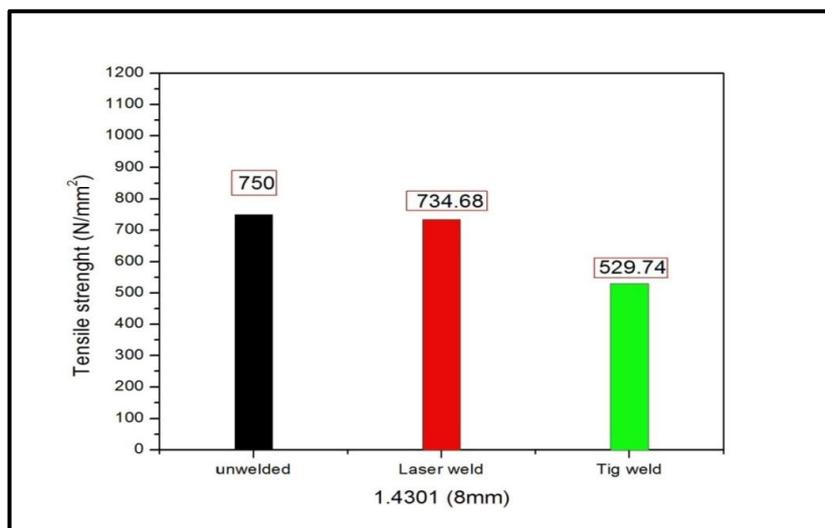
Figure 19 1.4301 A.S.S Tensile strength

Tensile strength testing was carried out for laser and Tig welding for comparison unwelded metal was used thickness 8mm. Observed that the weld done to the specimens done well compared to the original unwelded specimen that the tensile strength almost close to literature results (750 N/mm^2) fig.19. After several tests observed that the main reason about failing was some of the weld defects found in the weld zone that contain pores and cracks would weaken the material and can be affected by corrosion resulted in failure of the specimen below suspected breaking part. the incomplete penetration debilitates the material totally as the welding zone turns out to be not exactly the original measure. Compared to micro hardness measurement its assure that in the Tig weld its hardened which cause the failure at lower strength than Laser weld and the base metal. Through visual investigation of the tested specimens, the materials that performed best were the materials that had the least imperfections. In this manner, to choose which materials had the more exact welding conditions, we observe which specimens had the most elevated average ultimate strength.

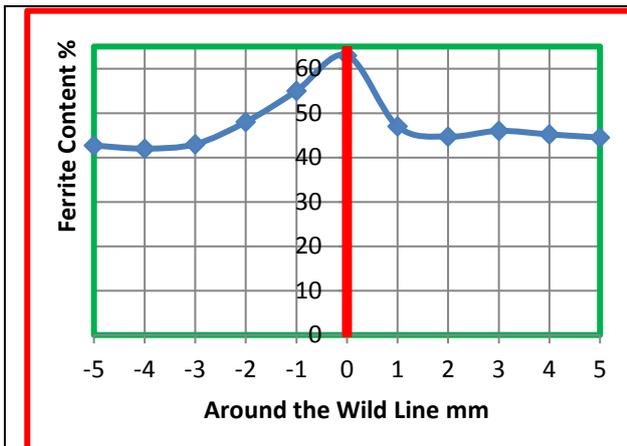
Figure 20- 1.4301 A.S.S ferrite % for top surface for Laser weld

For the Stainless steel 1.4301 samples shown that during the probe passing across the specimen that the Ferrite % increased along moving across heat affected zone followed by the maximum in the weld zone which has lower corrosion resistant will be confirmed later in corrosion study happen due to the precipitate in the HAZ as found in figures (18 and 19) for top surfaces, figure (20 and 23) for side surfaces.

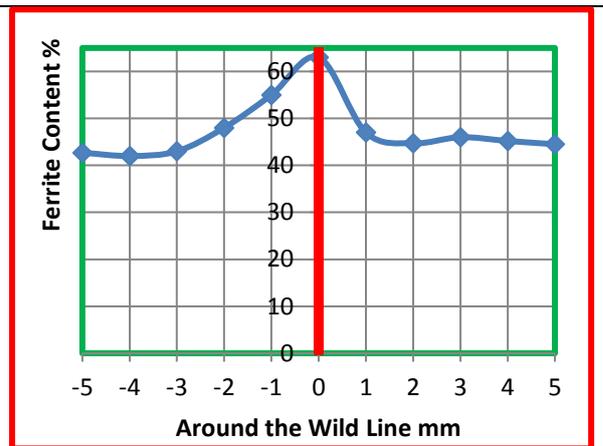
Figure 21 1.4301 A.S.S ferrite % Top Surface for TIG weld

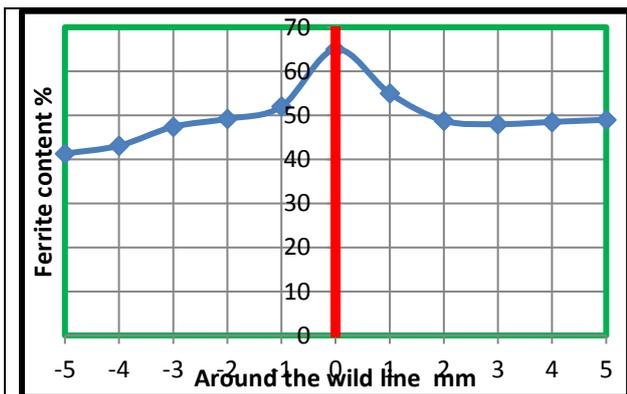
Figure 22-1.4301 A.S.S ferrite % for side surface for Laser weld

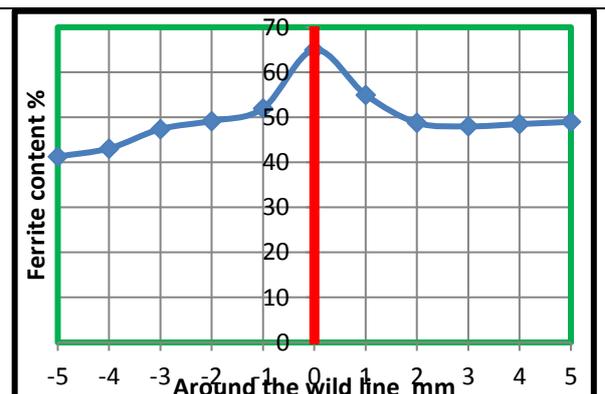
Figure 23-1.4301 A.S.S ferrite % Side Surface for TIG weld

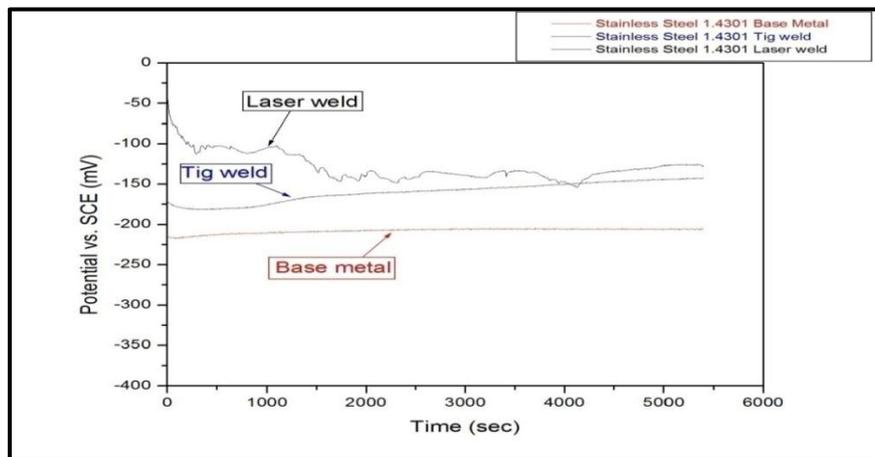
Figure 24- 1.4301 A.S.S OCP

In the above fig.24 in A.S.S 1.4301 the laser welded has a higher OCP values than the TIG welded and the Base metal (unwelded). Which illustrates that the welded material (Laser-Tig) has a higher passivity than the unwelded material in environment of 3.5% NaCl. At 4500sec (75mins) the laser -134.12mV compared to TIG which is -146.68mV the base metal(unwelded) is -205.68mV. As going from Laser welded specimen followed by the TIG welded specimen which indicates that the less negative potential direction is indication towards corrosion value happens due to the formation of carbides around the grain. The increase of potential from laser welds to TIG weld then the base metal may conclude laser re-passivation more corrosion resistant than TIG weld.

The open-circuit potential (OCP) give an indication about the dynamic behavior of the passive oxide layer film, whereas the more positive value for the OCP, the more the material becomes noble and corrosion resistant.

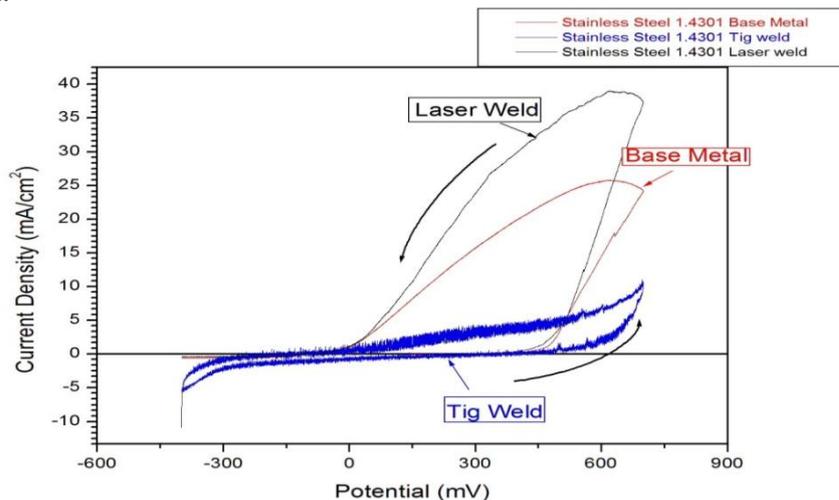
Figure 25 1.4301 A.S.S PCV

After conducting the Potential cyclic voltammetry for scan rate 2mV/sec from -400mV to 700mV it was seen from fig.25 for the laser weld is more pitting resistant comparing it to the corrosion rate of laser 9.436 mm/Y to the Tig welded 8.895 mm/Y from table4.
