Military Technical College
Kobry El-Kobba
Cairo, Egypt

12-th International Conference
on
Aerospace Sciences &
Aviation Technology

FAILURE AND DAMAGE ANALYSES OF AL-7075 MATRIX COMPOSITE REINFORCED WITH SiC_p AFTER BALLISTIC IMPACT

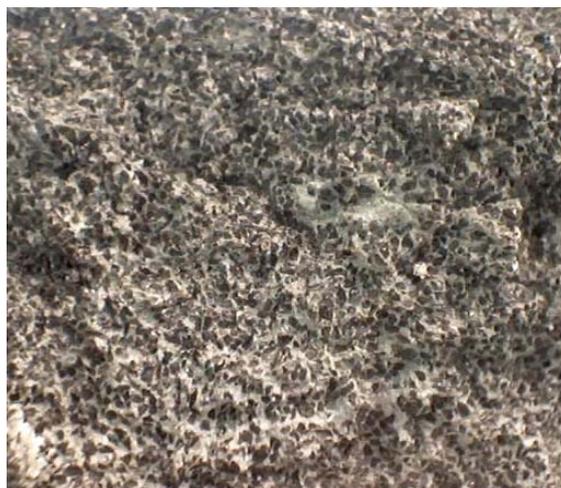
Figure 2. Composite structure

The microstructure of the composite material manufactured for this study can be seen in Fig. 2. It is clear that the SiC particles are dispersed homogenously in the structure. This is very important factor for the ballistic performance of the target.

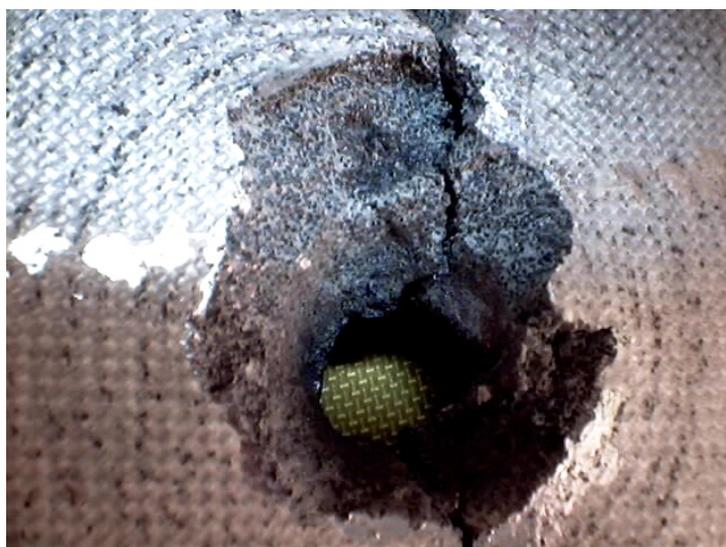
Figure 9. The damage on the Al- 20%SiC Composite target without backing block

If the impacting is established on the target without backing plate, the damages occurred at the entrance and exit side of the hole are severe as can be seen in Fig. 9. Because, in the case of using backing plate, some of the impact energy is consumed by the backing material while the energy is reacted to the target itself. Therefore, the target without backing plate experiences severe damages than that of the other one.
