12-th International Conference  
on  
Aerospace Sciences &  
Aviation Technology

## **IMPACT DAMAGE EVALUATION OF FIBRE-REINFORCED COMPOSITE MATERIALS AND STRUCTURES**

Jang-Kyo KIM\*

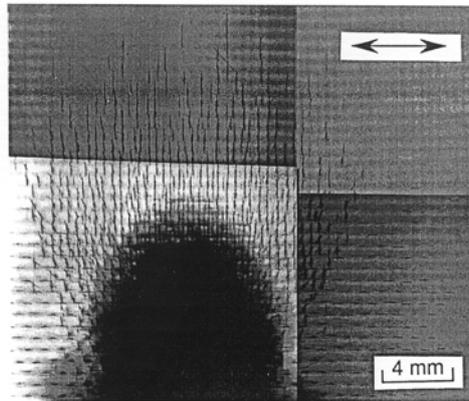
Fig. 1 A magnified view of impact damage in a glass fabric-vinyl ester matrix composite. After Hirai et al. [6].

It was shown that visual inspection of glass fibre-thermoset matrix composites could reveal internal defects and damage. The reduction in transmission of light by delaminations can be accurately quantified using a solid state camera, whose image can be stored in a computer for the construction of digitised images. An optical microphotograph of a glass woven fabric vinyl ester matrix composite taken with the aid of transmitted light is shown in Fig. 1 [6,7]. In addition to the extensive delamination observed in the central impact area, minute interface debonding occurred along the warp and weft directions of woven fabric in the surrounding regions near the back surface of impact, which contributed considerably to the total damage area of the

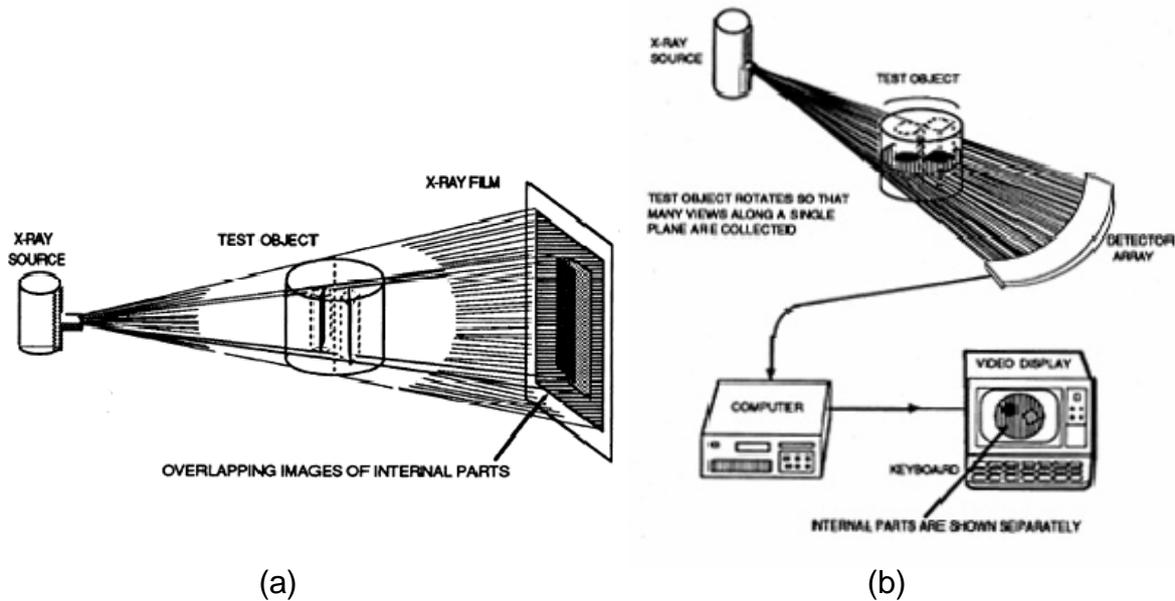
Fig. 2 Schematic diagrams comparing (a) conventional X-ray radiography and (b) X-ray computed tomography (CT).

produces a shadowgraph representing the attenuation experienced by the X-rays, the CT process utilises X-ray intensity measurements and computes an image of the specimen cross-section. The computed image is a highly accurate representation with a very fine resolution of the attenuation scale. The real time viewing of X-ray images can reduce the demand for X-ray films.

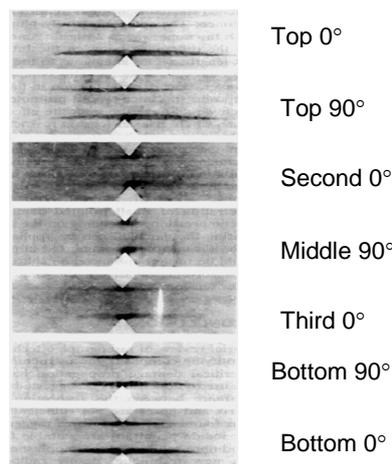
Fig. 3 De-ply X-radiographs of a  $[0^\circ/90^\circ]_{2S}$  double-notched carbon fibre-epoxy matrix composite laminate after fatigue loading. After Kortschot and Zhang [8].

De-ply radiography involves a combination of standard radiography and the aforementioned de-ply technique. The laminate is first penetrated with a solution of zinc iodide and the resin is subsequently pyrolysed in a furnace, resulting in the separation of the individual layers. The radiographs of these laminae provide a 3D map of damage pattern. The series of radiographs in Fig. 3 [8] present the extent of notch tip damage in a  $[0^\circ/90^\circ]_{2S}$  double-notched carbon fibre-epoxy matrix composite laminate after fatigue loading. The dark images of the photograph indicate the dye penetrant-filled cracks. The comparison of the radiographs taken before and after pyrolysis indicated that the resolution of the image was severely impaired by pyrolysis although the overall distribution of damage was visible after pyrolysis. This technique has a major limitation where each radiograph represents the sum of the image from both sides of an individual lamina.

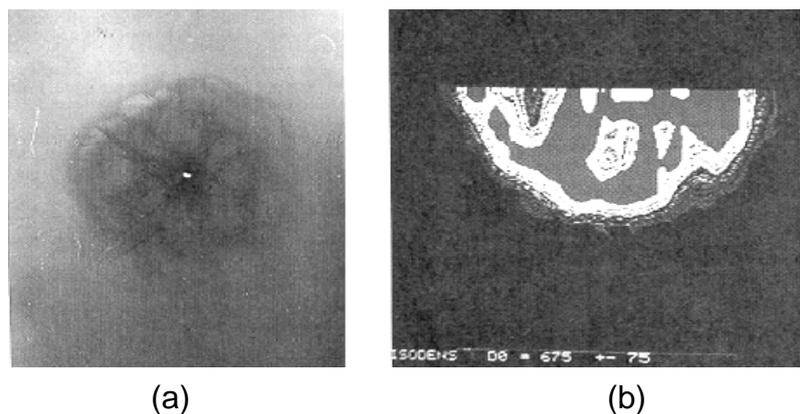
Fig. 4 Comparison of (a) conventional X-radiography and (b) computed tomography (CT) images of 28 layer quasi-isotropic carbon fibre-epoxy matrix composite laminate after impact. After Bathias and Cagnasso [10].

Major advantages of using X-ray CT techniques are good contrast sensitivity and high resolution. It was claimed that dimensional changes less than 0.01% and variations of density less than 0.1% could be detected, and the resolution of typical CT instruments for medical and industrial applications was as high as 25 $\mu$ m. Although it is relatively difficult to provide enough resolution to detect tightly closed delaminations compared to ultrasonic C-scan techniques, the CT technique has been successfully applied to resolve composite defects, such as matrix cracks, delaminations and fibre bundles. Fig. 4 [10] suggests that a CT image alone provided much better resolution of the outline of the damage area than the planar view of X-radiography. Internal damage in a SiC fibre-reinforced aluminium matrix composite under static tension was also successfully observed by the in situ X-ray CT technique based on a synchrotron radiation.

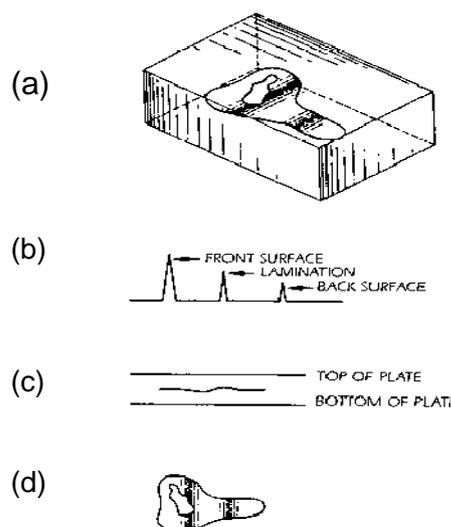
Fig. 5 Comparison of ultrasonic scanning techniques: (a) A specimen containing a delamination; (b) A-scan wave; (c) B-scan view; (d) planar view of C-scan. After McIntire [11].

Once the composite part is scanned at regular intervals across its surface, the ultrasonic map of defects can be presented in three different modes, namely A-scan, B-scan and C-scan, as shown in Fig. 5 [11]. In the A-scan mode, the attenuated signals are displayed as a series of peaks against the time scale on an oscilloscope. The position of its echo along the time axis allows the defect location to be detected in the thickness direction, while the amplitude of the echo can give some indication of the size and nature of the defect. In the B-scan analysis mode, cross-sectional measurement can be made along any vertical plane, eliminating the need for destructive cross-sectioning of specimen. B-scan is basically a series of very close-spaced A-scans through the thickness of specimen.

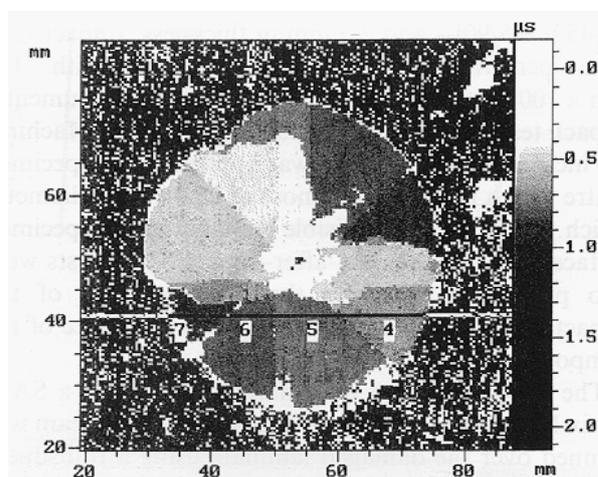
Fig. 6 SAM photograph of the gross impact damage in a 16 layer  $[(-45^{\circ}/0^{\circ}/45^{\circ}/90^{\circ})_2]_s$  carbon fibre-bismaleimide (BMI) matrix composite. After Gao and Kim [5].

The 3D distributions of impact damage in carbon fibre composite laminates containing several different types of thermosets and thermoplastics have been studied using SAM [5,14,15]. Fig. 6 illustrates a SAM photograph of the gross damage in a carbon fibre-bismaleimide (BMI) matrix composite obtained from the multiple C-scan. The total damage area had a circular shape, consistent with previous observations from conventional C-scan analysis for similar systems and lay-up sequence. The level of grey colour from light to dark grey indicates the depth of the layers containing such delaminations from the front surface. The SAM images of ply-by-ply C-scan and TOF analyses for the top eight layers are presented in Fig. 7. The former images provided

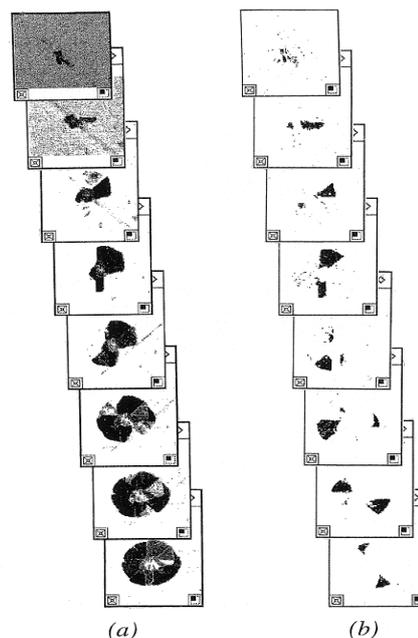
Fig. 7 SAM photographs taken from (a) ply-by-ply C-scan; (b) time-of-flight (TOF) analysis for the composite as in Fig. 6 [5].

information about accumulated damage toward the back surface, while the latter images allowed accurate measurements of damage area and shape at the individual layers.

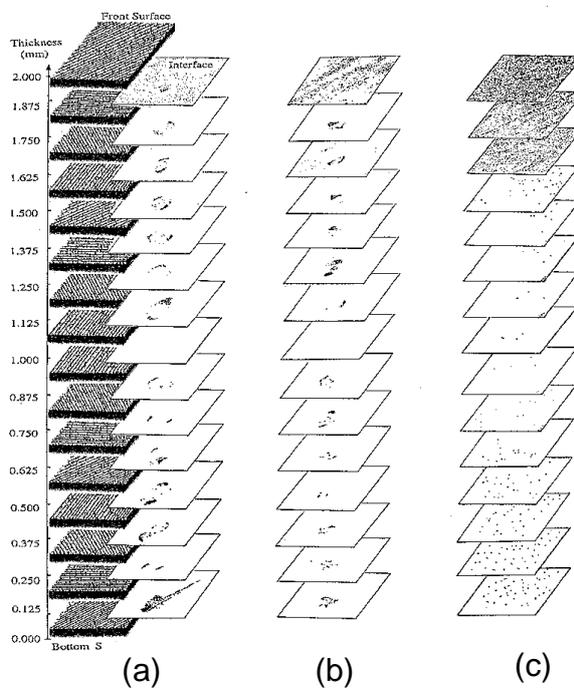
Fig. 8 SAM images obtained from the TOF analysis of the impact damage in quasi-isotropic (a) carbon-epoxy; (b) slow-cooled carbon-PEEK; (c) fast-cooled carbon-PEEK laminates at an impact energy of 12 J. After Gao and Kim [14].

The impact damage resistance of carbon fibre composite laminates as determined by several damage parameters was controlled by the type of matrix material and the processing condition [5]. Fig. 8 shows the SAM images generated from the TOF analysis of the impact damage in carbon fibre composites with epoxy and polyetheretherketone (PEEK) matrices. The reflected signals observed in the front and back several layers of the fast-cooled carbon-PEEK system did not represent damage, but were due to the high damping characteristics of PEEK. Fig. 9 presents the corresponding total delamination area and the residual strength plotted as a function of impact energy. The delamination area was small in the order of fast-cooled, slow-cooled carbon-PEEK and carbon-epoxy systems for a given impact energy level. Meanwhile, the incipient impact energy,  $U_i$ , below which no delamination occurred was low in the same order, indicating the impact damage resistance was superior in composites of the same order (Fig. 9 (a)). The ability to predict the residual strength of a damaged structure is of particular importance for an effective damage tolerant design. Impact damaged composites experience significant strength reduction [16,17]. The residual strengths were higher in the order of fast-cooled, slow-cooled carbon-PEEK and carbon-epoxy systems, although the absolute strength values were slightly higher for the slow-cooled composites than for the fast-cooled counterpart (Fig. 9(b)). The threshold impact energy,  $U_0$ , below which no strength degradation took place, was also highest for the fast-cooled carbon-PEEK system. All these observations indicates that the slow-cooled composites contained PEEK matrix with a high degree of crystallinity, giving rise to high strength and stiffness, whereas the relatively high ductility of amorphous-rich PEEK matrix in the fast-cooled composite enhanced the interlaminar fracture resistance.

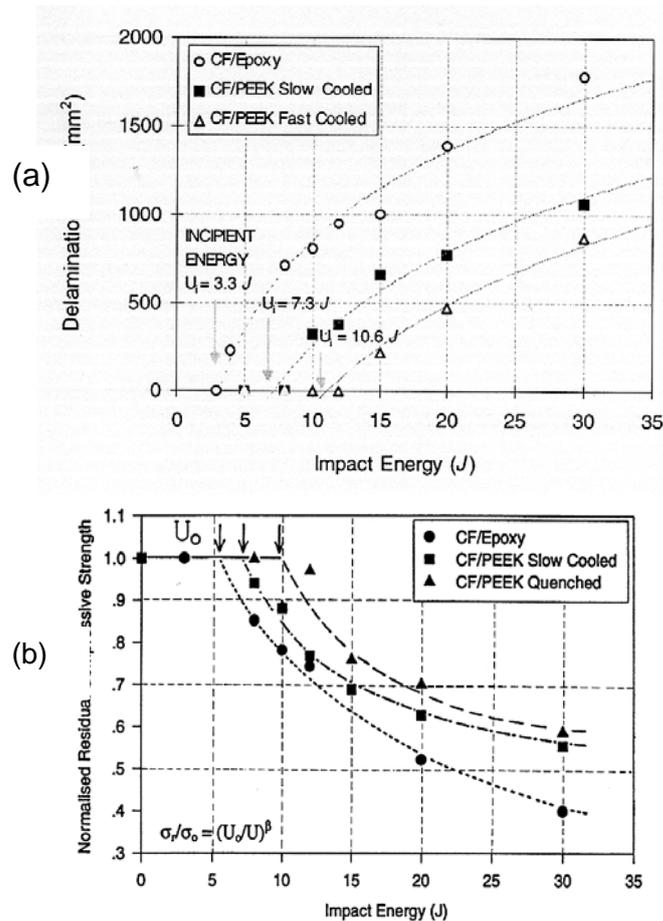
Fig. 9 (a) Total delamination area and (b) CAI residual compressive strength versus applied impact energy. The incipient impact energies,  $U_i$ , and the threshold impact energies,  $U_0$ , for three composites are indicated. After Gao and Kim [14].
