Biaxial loading after low-velocity impact response on scarf repair glass fibre reinforced polymer (GFRP)

Abstract. The composite material has become one of the most used materials in several applications, such as aviation, marine, and civil sectors, because of its lightweight and high-strength properties. Therefore, the wide use of this material has made it essential to explore its durability and efficiency, in particular, after repair processes. The present work investigates the effect of impact energy and its location on the remaining strength of scarf-repaired glass fibre composite. The study was conducted in two phases; in the first phase, a low-velocity impact test was carried out at specified impact locations according to the central composite statistical experimental model. A visual inspection was then performed to evaluate the damage size to the impact energy. In the second phase, tests based on biaxial loading were performed up to the failure of the repair. Then, a central composite design model was used to explore the effect of various factor levels. Results showed that the model fits firmly by 93.07% of the variability in biaxial loading. Additionally, the model showed

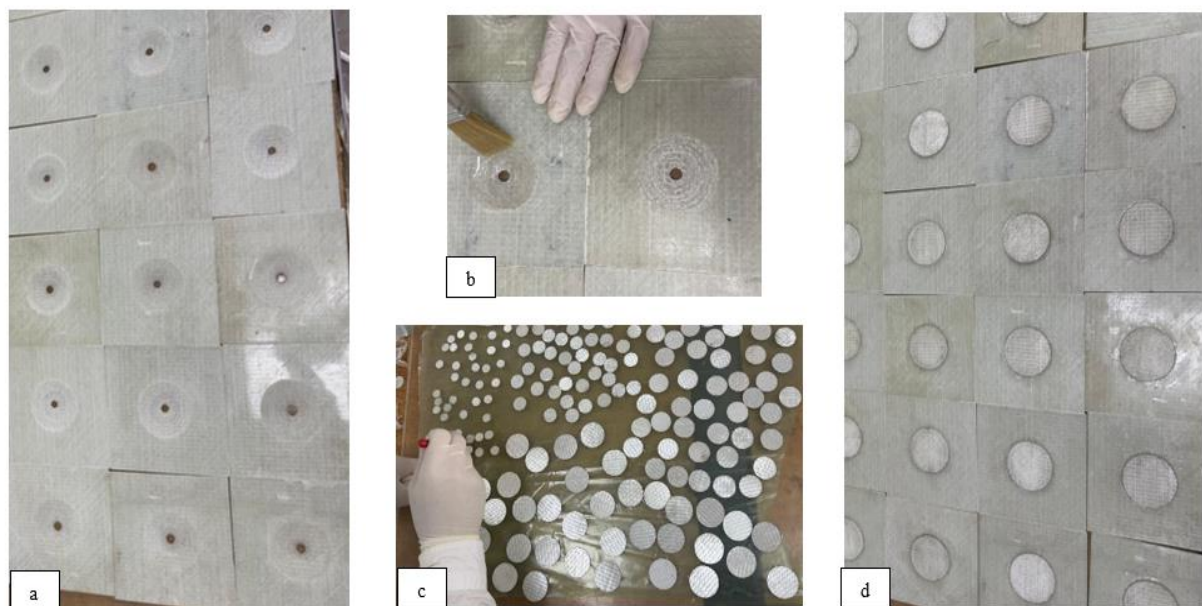
Figure 2. a) specimens after sanding, b) Resin applied, c) plies rolled with resin, d) final specimens before applying biaxial loading

According to ASTM D2093-03, each scarfed sample was prepared through identical scarfing steps. Seven layers of plies were cut into circular shapes using a laser machine to ensure the accuracy of small diameters, as shown in Figure 2. These diameters were calculated using the scarf angle and the geometry of the taper hole. Furthermore, the same resin was applied over the tapered hole, and the plies rolled by the resin one after the other. The pressure was applied to the scarf hole to ensure that the resin and plies entirely covered the scarf hole to avoid void formation. The curing process was also done at room temperature.
